Statewide Survey of Historic Properties

Site Number: 326-0427.01

Survey Report for McClellanville

Historic Name: Doar Kitchen building
Common Name: Doar Kitchen building
Address/Location: 125 Oak Street (rear) (127 Oak Street per Chas Co)
Ownership: Private
Historical Use: Domestic
Category: Building
Current Use: Domestic

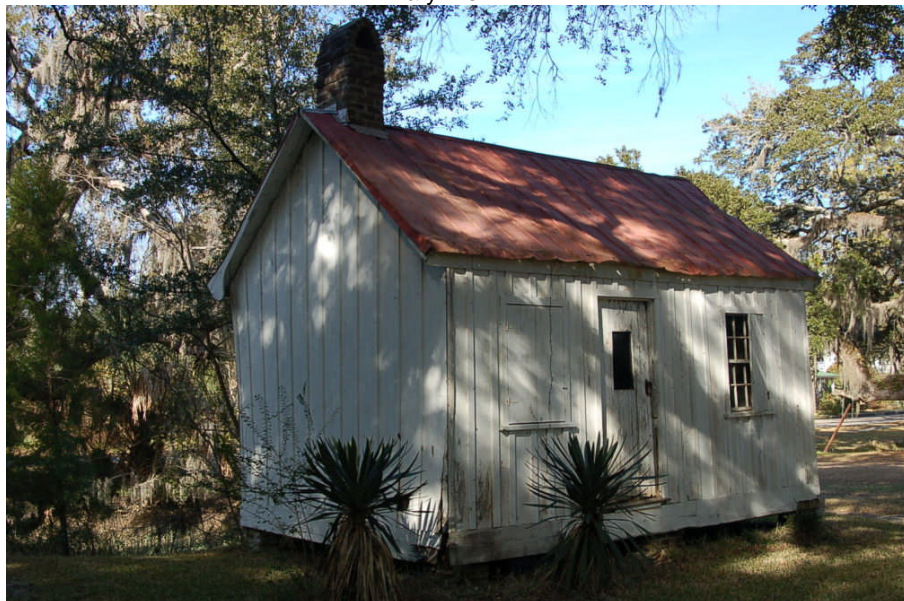
Primary View:

Significant Architectural Features: Board and batten siding; 6/6 windows flank central beadboard entry door on south elevation; Windows are shuttered with vertical board shutters; interior brick chimney with gothic cap on west end of building.

Alterations: fixed light in entry door; in state of disrepair.
